**MARYLAND HISTORICAL TRUST
DETERMINATION OF ELIGIBILITY FORM**

Property Name: Keefer-Markell Farmstead Inventory Number: F-1-208
Address: 4944 Buckeystown Pike City: Lime Kiln Zip Code:
County: Frederick USGS Topographic Map: Buckeystown
Owner: Old Chapel Corporation C/O Chevy Chase F.S.B. Is the property being evaluated a district? ☐ yes
Tax Parcel Number: 3 Tax Map Number: 86 Tax Account ID Number: 005642
Project: Westview South Agency:
Site visit by MHT Staff: ☒ no ☐ yes Name: Date:
Is the property located within a historic district? ☐ Yes ☒ no

Continuation Sheet No. 1

F-1-208
KEEFER - MARKELL FARMSTEAD
Lime Kiln
Frederick County, Maryland
Resource Sketch Map, Keyed
Drawn By: ES, BW
May 2004

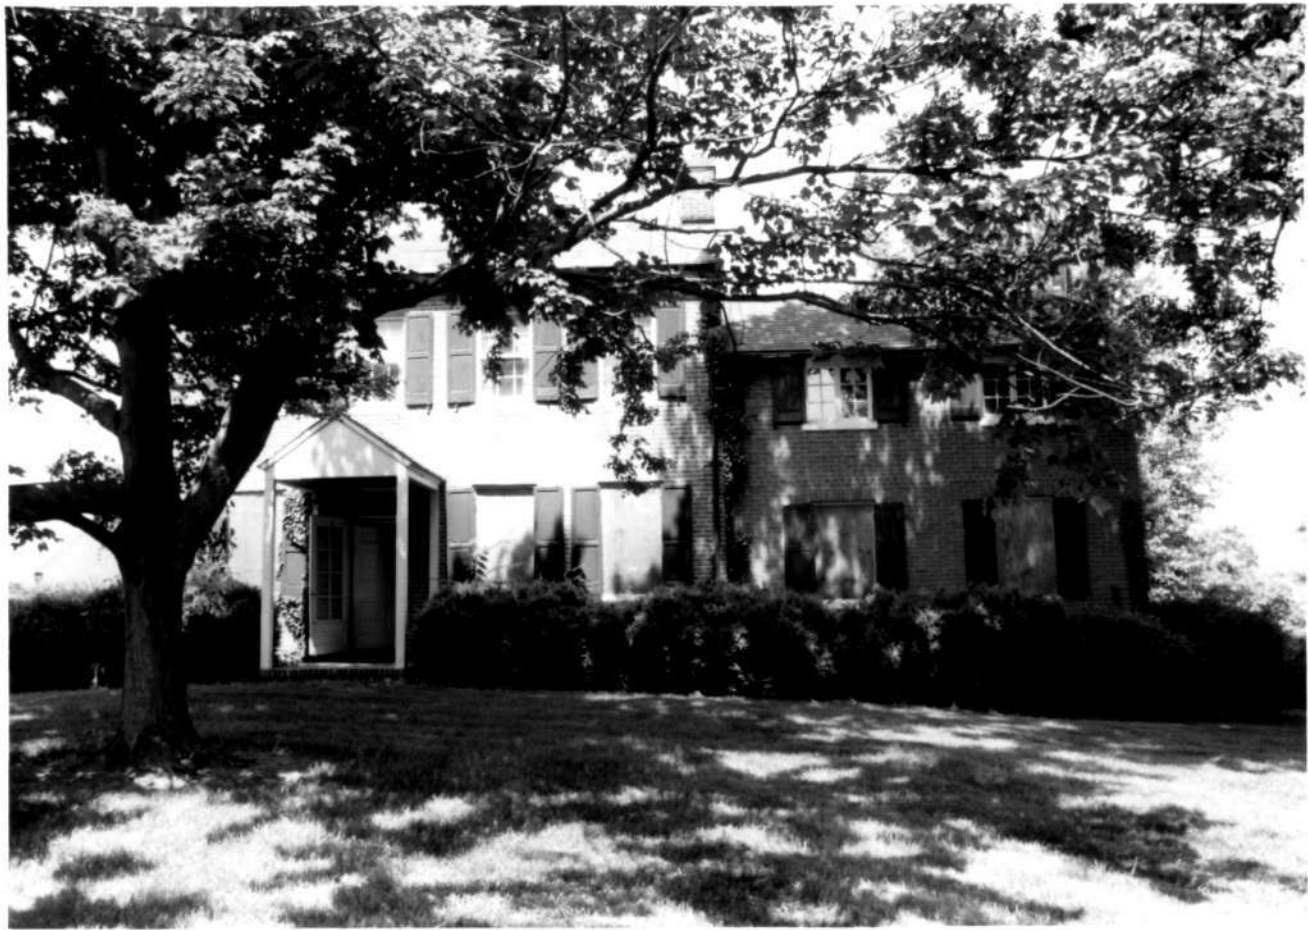
1 OF 18

MAIN DWELLING, VIEW NW

The ca. 1840 farmhouse is recessed from both New Design Road and Buckeystown Pike and sits perpendicular to the driveway. The two-story dwelling faces south. The dwelling consists of a main block and two additions that were constructed in ca. 1860 and ca. 1953. The brick dwelling occupies an L-shaped plan. The stone foundation was visible only under the porch located on the dwelling's northwest elevation. The dwelling terminates in a gable roof that is defined by a box cornice and sheathed in asphalt shingles. Windows consist of six-over-six light, double-hung, wood sash, and twelve-light wood casement units. Four brick chimneys are present. Additions extend to the right (east) and the rear (north).

The earliest part of the dwelling is two stories tall and four bays long. The brick exterior was completed in 5:1 common bond. Flush gable end brick chimneys are located on the east and west elevations. The front (south) elevation is symmetrical, with the primary entrance located on the west, central bay. First and second floor window openings are characterized by jack arches. Windows consist of six-over-six light, double-hung wood sash units. Paneled shutters define the first and second floor windows. An off-center, gable-roof porch provides access to the dwelling. The gable roof porch is sheathed in asphalt shingles and is supported by square columns.

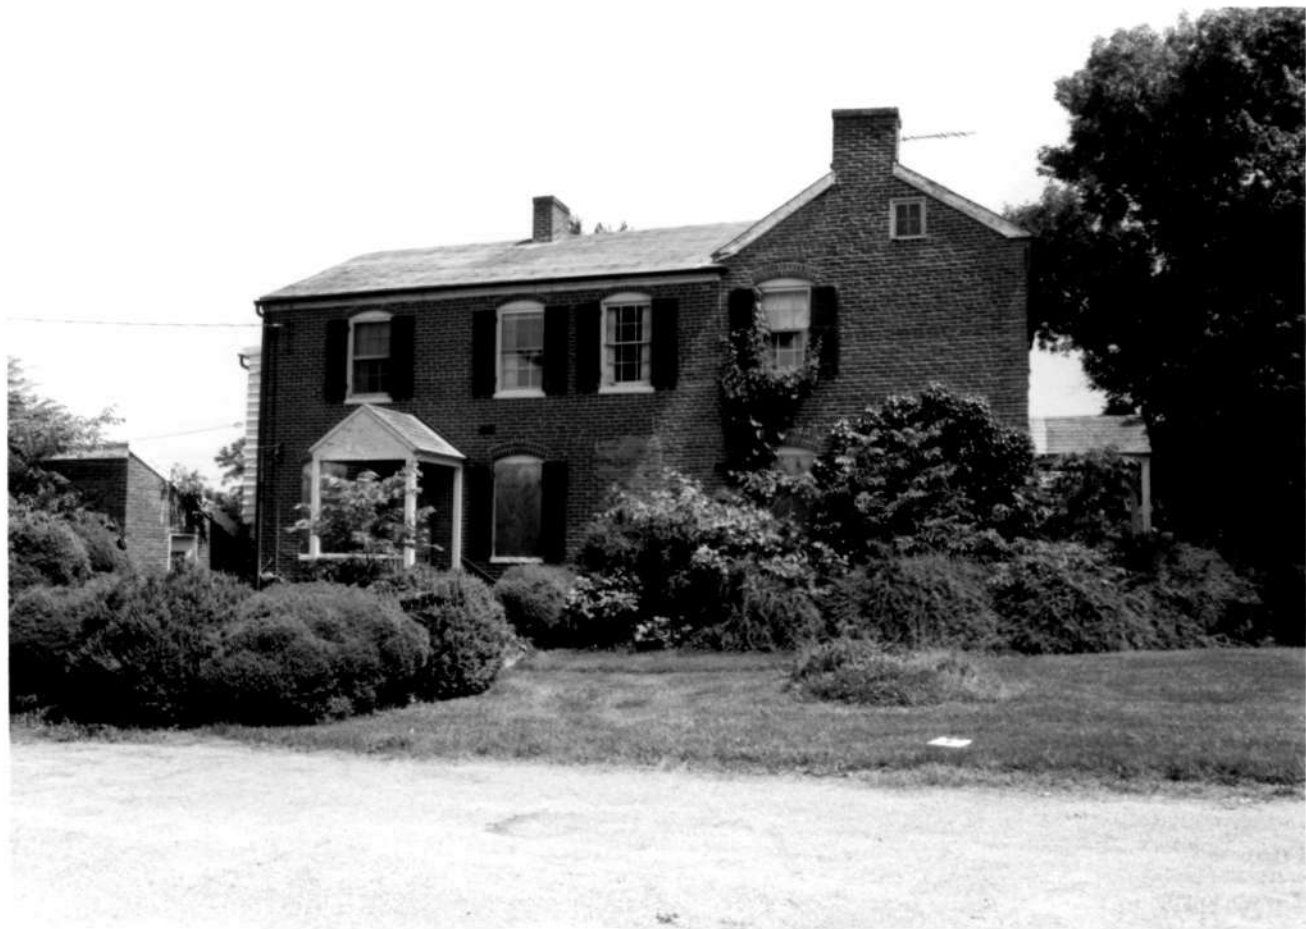
2 OF 18

MAIN DWELLING, VIEW NE

A ca. 1860 two-story, three-bay, brick addition was constructed north of the ca. 1840 building (See Resource Sketch Plan). Segmental arched windows characterize the east and west elevations of the addition. Windows on the first floor of the east elevation have wood louvered blinds. A porch similar to that found on front (south elevation) is located on the northern most bay of the addition's west elevation. An interior brick chimney characterizes the roof. A ca. 1953 wood frame addition was constructed to the north of the ca. 1860 section of the dwelling. It is clad in shiplap wood siding.

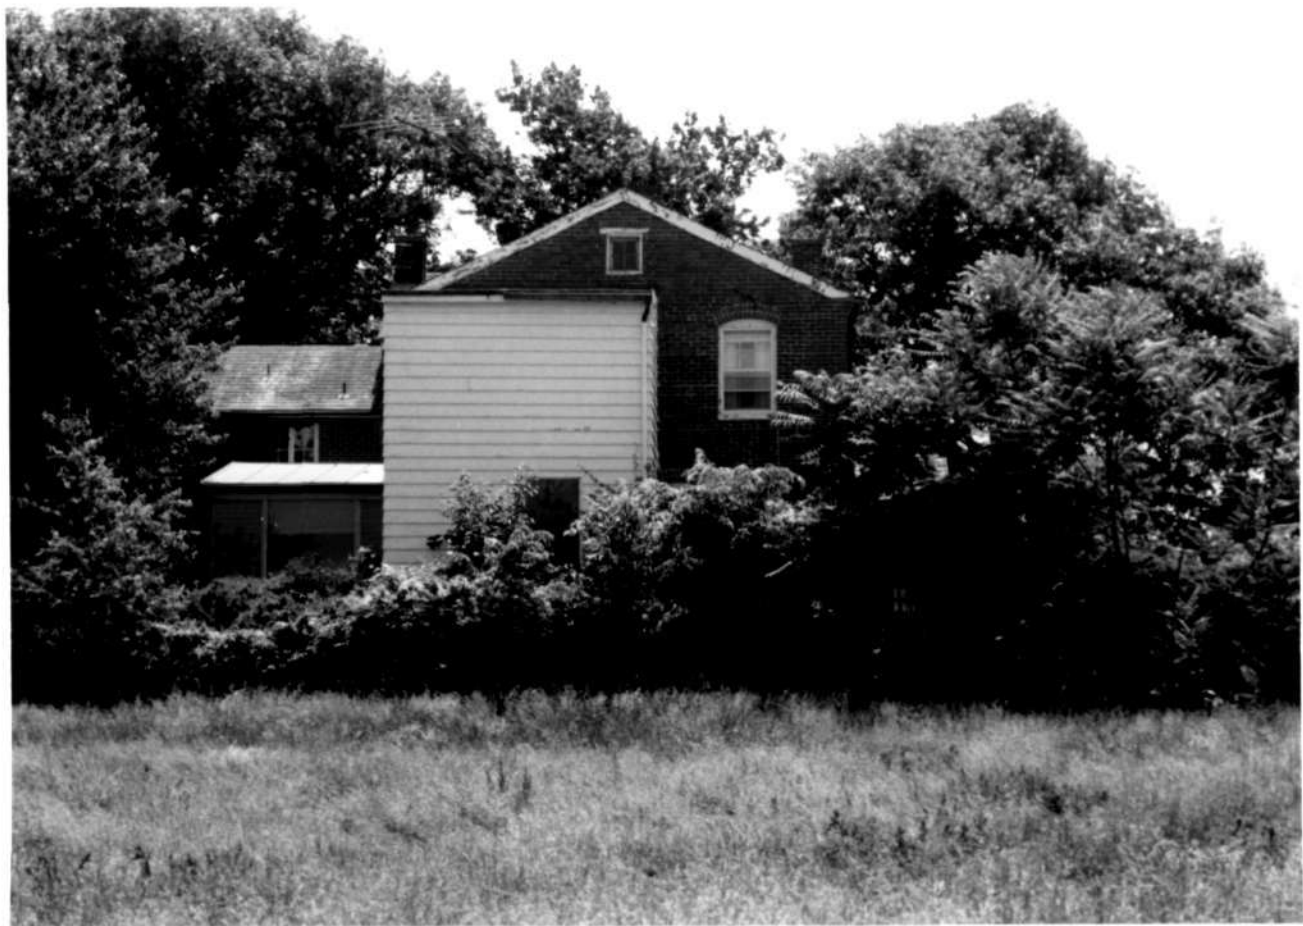
MAIN DWELLING, VIEW SE
3 OF 18

A ca. 1953 two-story brick addition was constructed to the right (east) of the original block (See Resource Sketch Plan). An exterior, gable end brick chimney is located on the east end of the addition. Jack arches define the window openings on the first floor. Six-over-six light, double-hung wood sash units are found on the first floor; twelve-light wood casement units are located on the second floor.

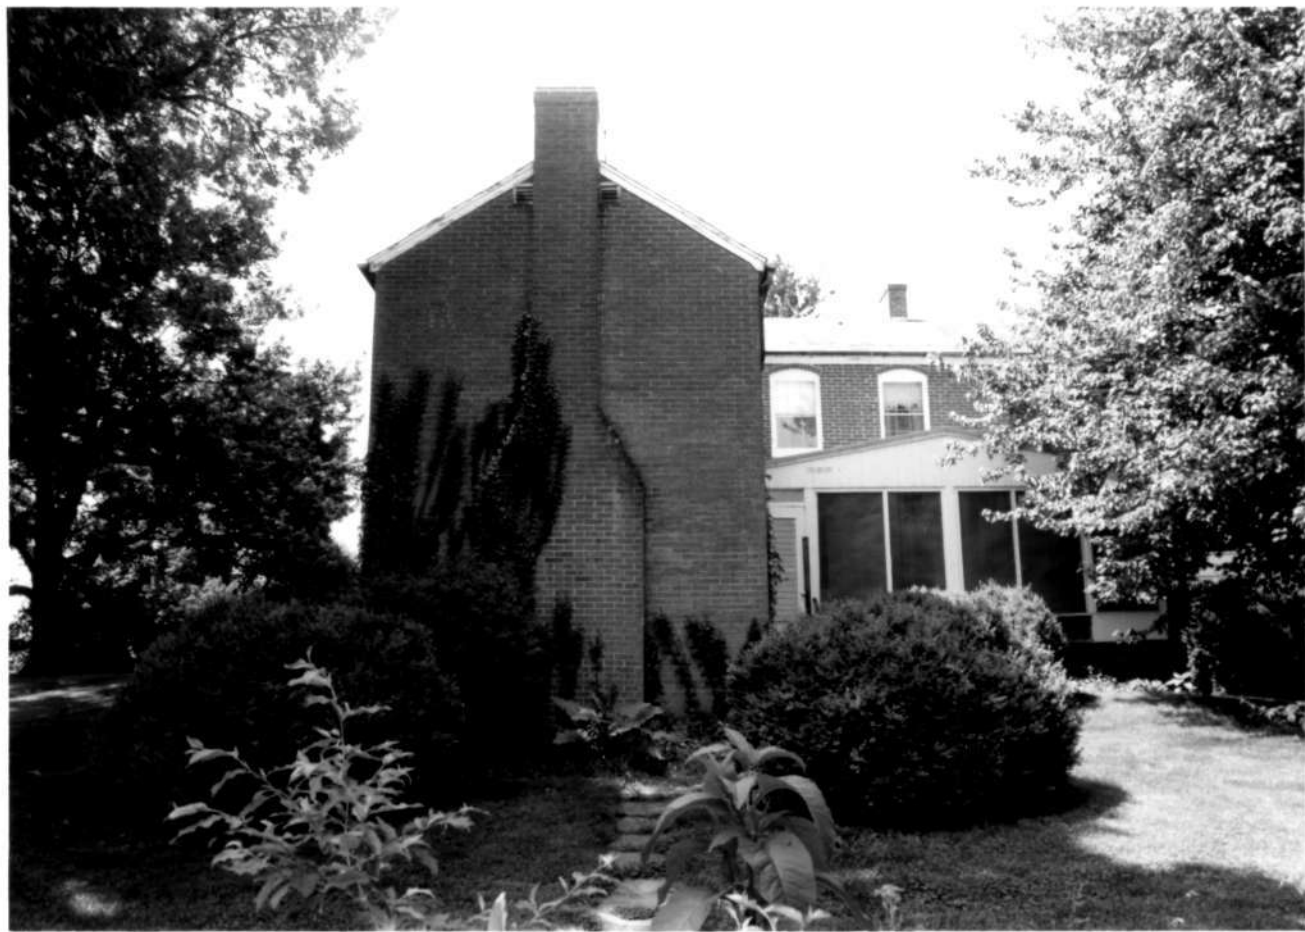
4 OF 18

MAIN DWELLING, VIEW SW

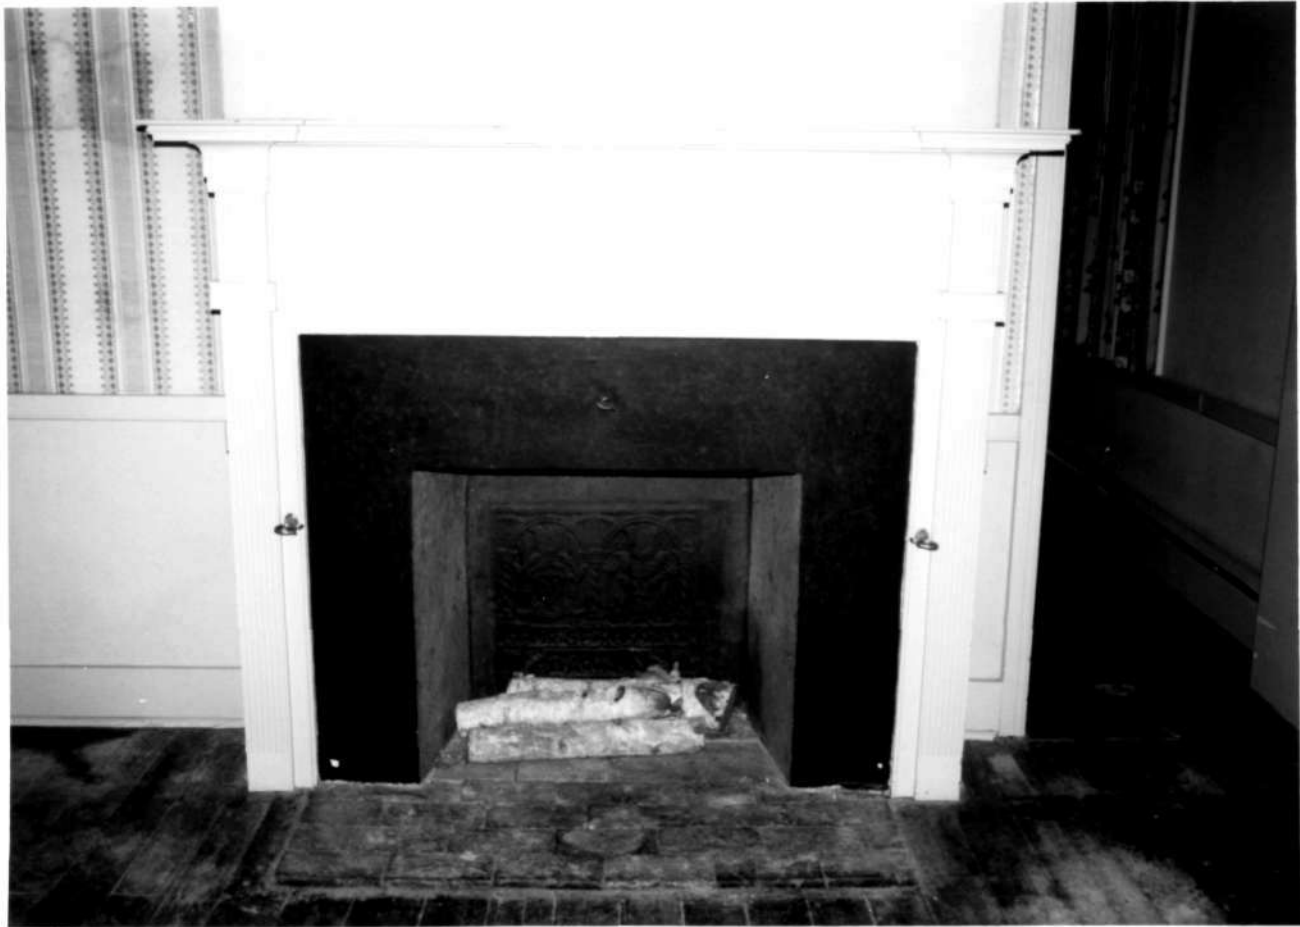
5 OF 18

MAIN DWELLING - MANTEL, FIRST FLOOR, VIEW NE

The main entrance opens into a large living room, which originally consisted of two rooms (Davis 1993). A quarter-turn, combination open/closed stair leads to the second floor. Interior decorative elements include wainscoting in each of the rooms, and corner blocks in some of the windows and doors. Wood mantels define the two east fireplaces.

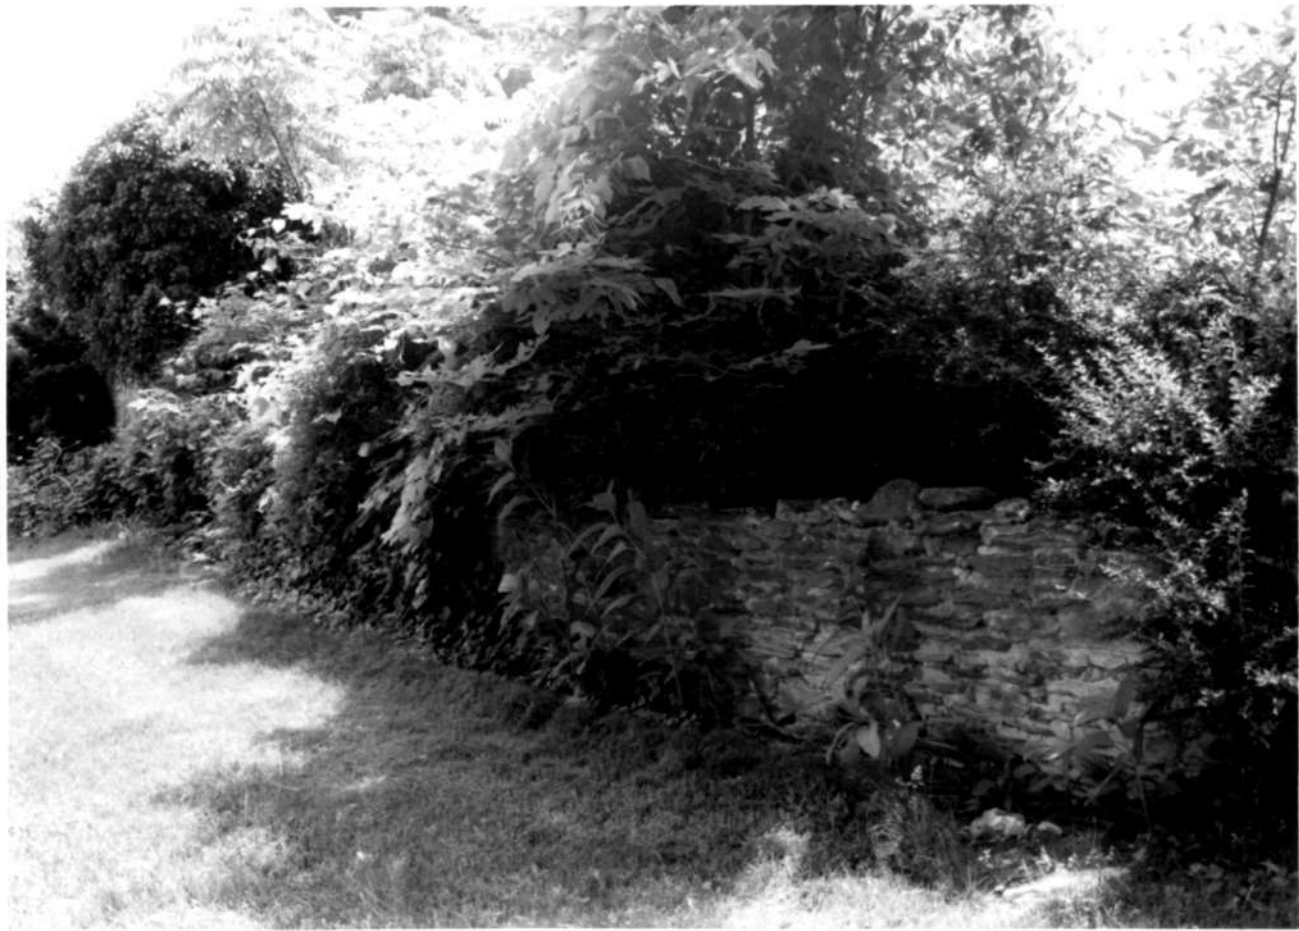
6 of 18

STONE WALL, VIEW SE

A brick path leads to a small garden located between the farmhouse and the meathouse. A brick path also leads to the west elevation, where a secondary entrance porch and brick patio are located. A stone wall runs north/south behind the meathouse. The wall varies in height, reaching a height of approximately four feet.

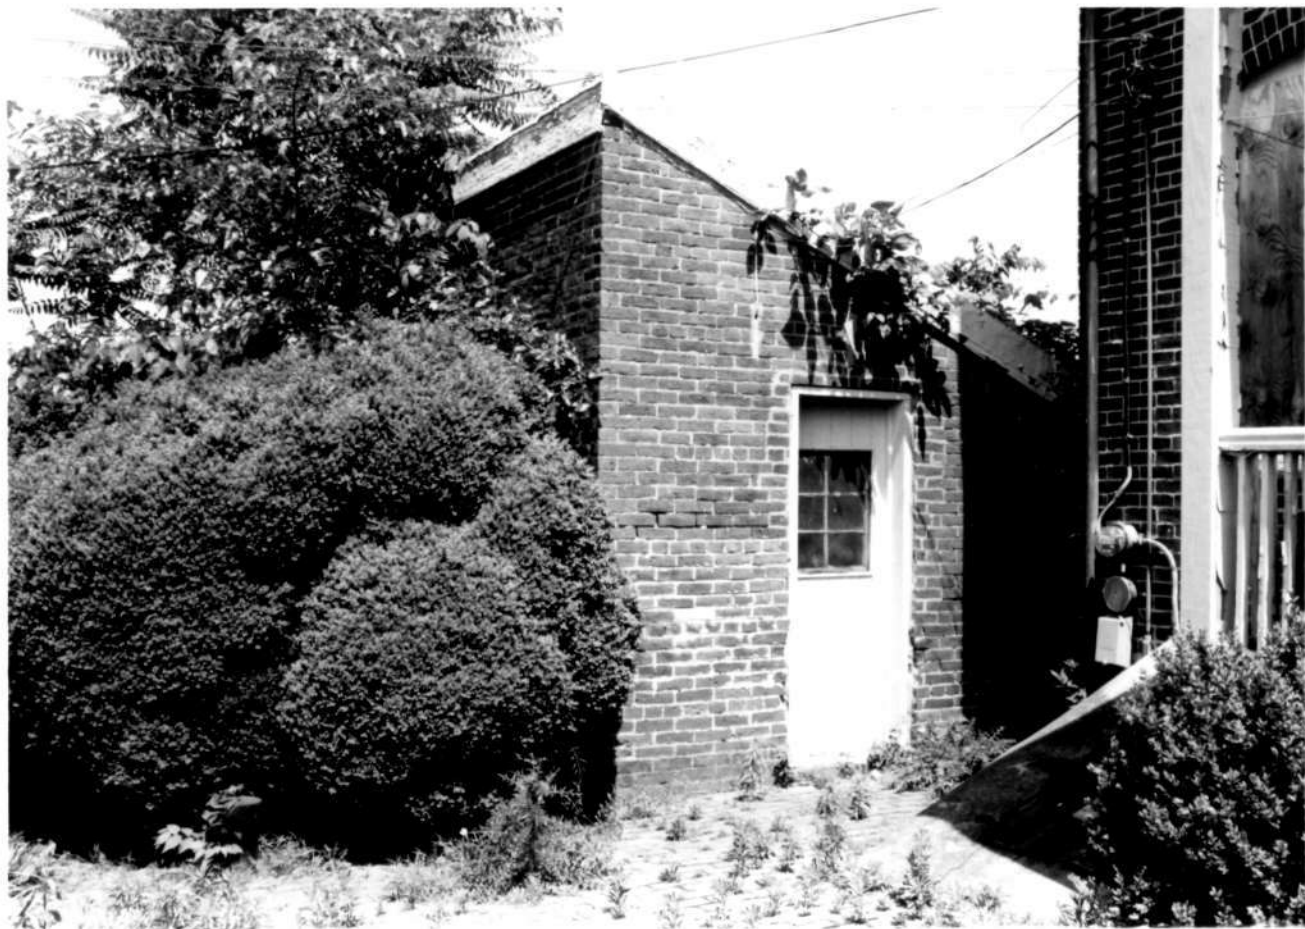
7 OF 18

MEATHOUSE (DAIRY, VIEW N

A ca. 1860 one-story brick building is located north of the farmhouse and faces south. The building might have functioned as either a meathouse or dairy. The single-cell building occupies a square plan and terminates in a shed roof; the foundation was not visible. Roofing materials were not visible at the time of the site visit, however, the MIHP form stated that the roof was sheathed in asphalt shingles. The building has two openings. A six-over-six light, window is located on the north elevation; materials and window type were not visible. The single door is centered on the south elevation and consists of a six-light, beaded wood door.

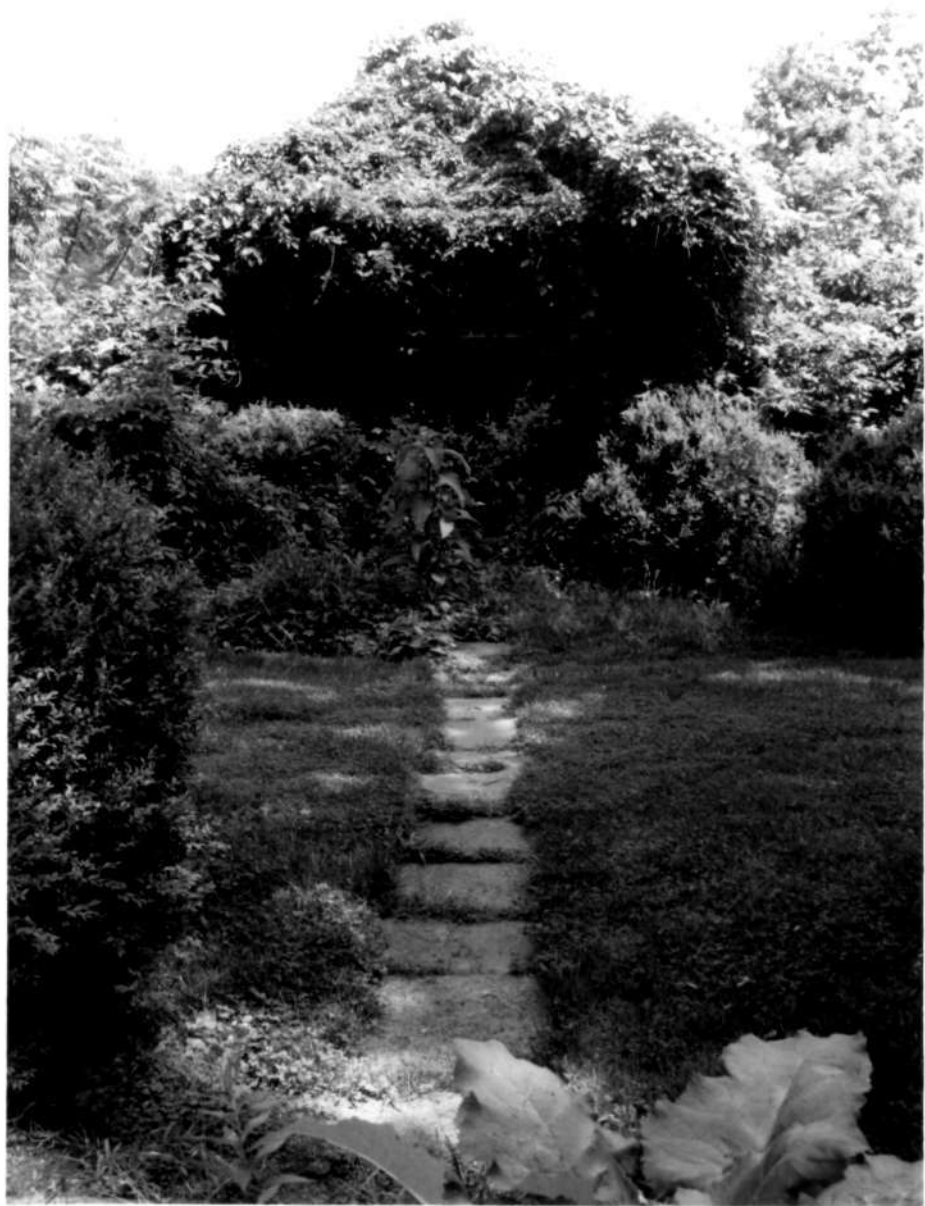
8 PF 18

SMOKEHOUSE, VIEW NE

The ca. 1840 smokehouse is located northeast of the dwelling. The one-story building with loft occupies a square plan. The building has a brick floor and stone interior. The building terminates in a pyramidal roof. Exterior cladding and roofing materials were not visible due to thick, overgrown vegetation. According to the 1993 MIHP form, the building was constructed of stone and the roof sheathed in wood shingles. A single door is centered in the southwest elevation. The door is constructed of wood, beaded board. In recent years, the smokehouse appears to have been used as a potting shed.

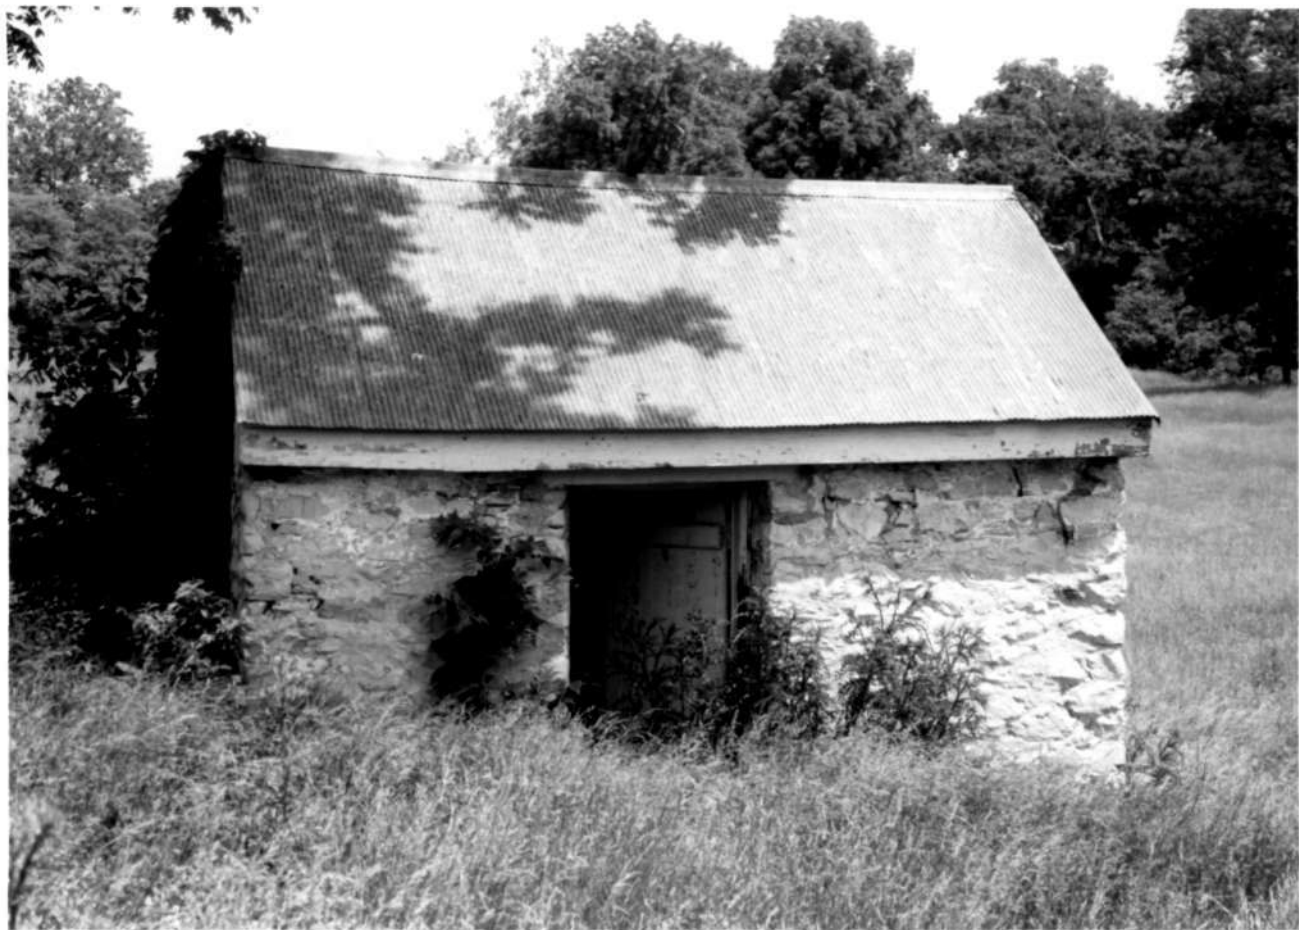
9 OF 18

SPRING HOUSE, VIEW NINE

The ca. 1840 springhouse is located northeast of the dwelling in an unmowed field. The building occupies a rectangular plan. The stone building has a brick floor and terminates in a gable roof sheathed in corrugated metal. A box cornice defines the roof. A weathervane characterizes the roof. Based on photos attached to the 1993 MIHP form, it appears that the weathervane was at one time located on the smokehouse. Two openings are located on the building. A window opening with a wood frame is located on the southeast elevation. The sash is no longer extant. Wood shutters define the opening. A single, beaded board door is centered on the west elevation.

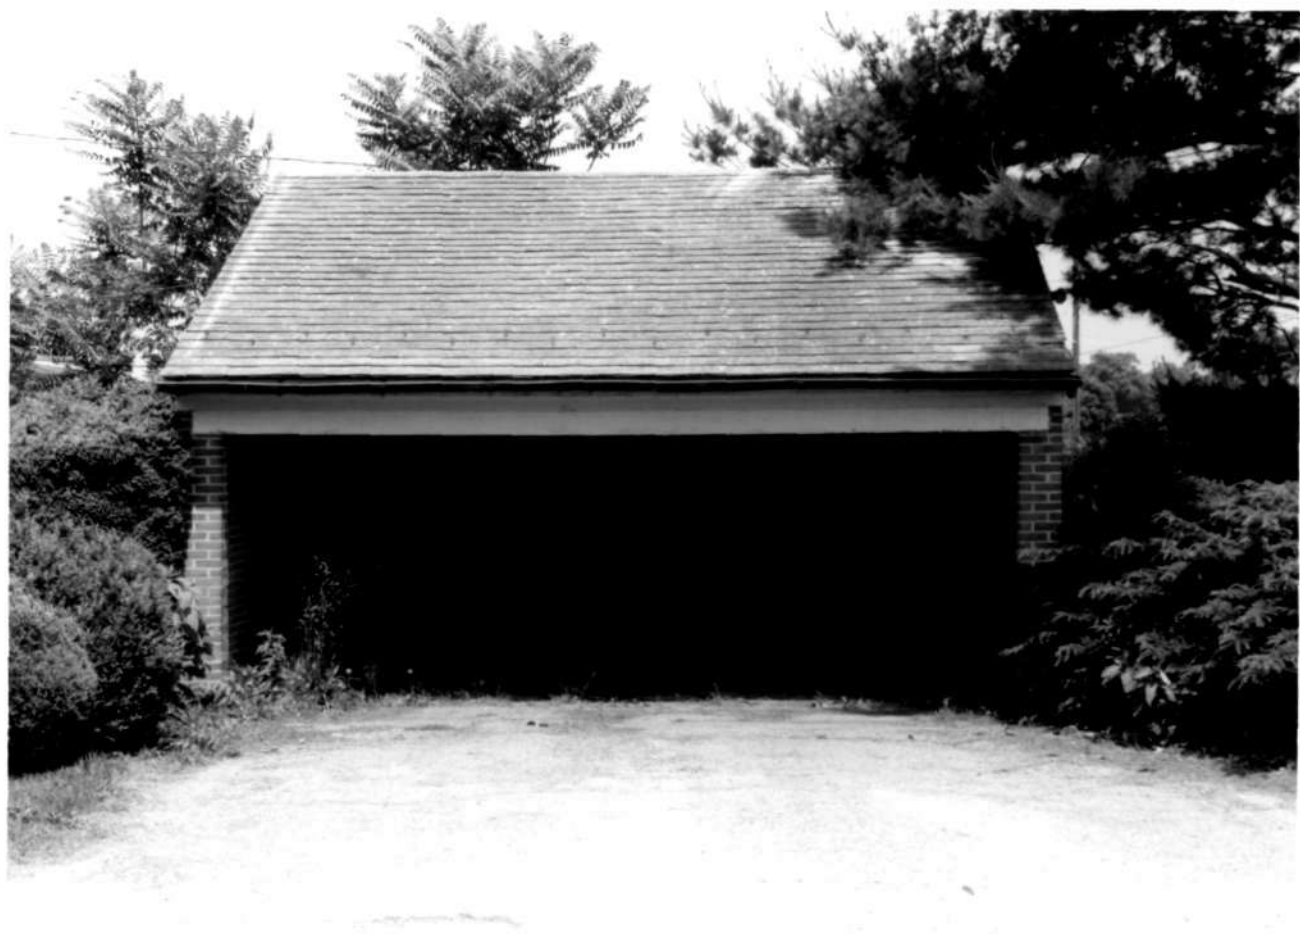
F-1-208
KEEFER-MARKELL FARMSEAD
FREDERICK COUNTY, MARYLAND
EVEN ST ONE
5/25/04
MD SAND
GARAGE, VIEW NW
10 OF 13

The ca. 1960 garage is located northwest of the dwelling and faces southeast. The brick garage is a one-story building that occupies a square plan. The building was executed in 6:1 common bond. The single-cell building rests on a concrete block foundation and terminates in gable roof sheathed in asphalt shingles. The garage floor was constructed of asphalt. The garage doors are no longer extant.

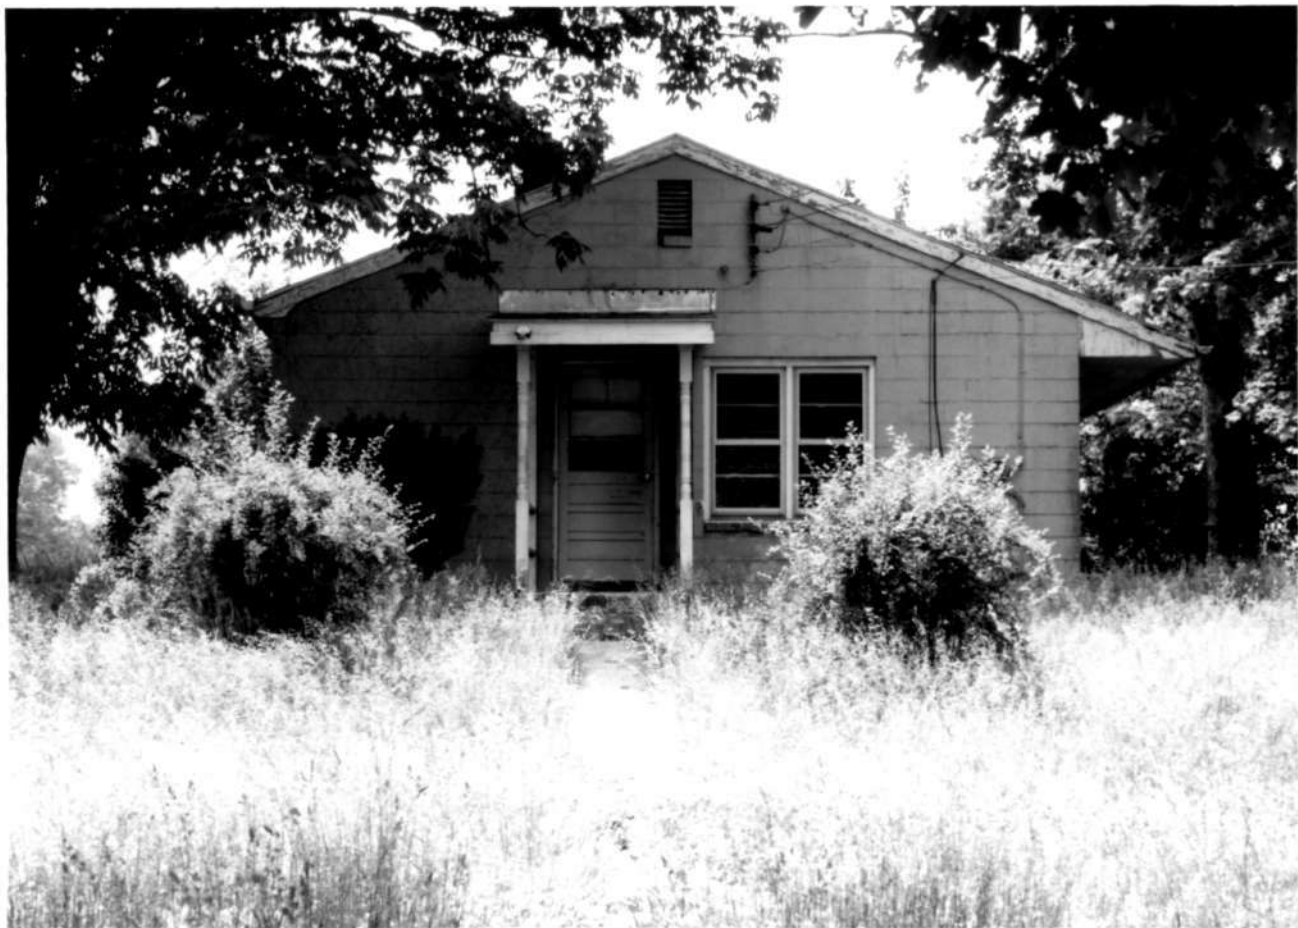
11 of 13

TENANT HOUSE, VIEW SW

A ca. 1959 concrete block tenant house is located northwest of the bank barn. The dwelling occupies a rectangular plan and rests on a poured concrete foundation. The dwelling terminates in a gable roof sheathed in asphalt shingles. The building faces east. An off-center, off-gable brick chimney is located on the east elevation. Windows are of various sizes and consist of two-over-two-light, double-hung, wood-sash and vinyl-sash units. An off-center shed roof porch on the east elevation is supported by turned, wood columns. Two concrete steps provide access to the entry. A three-panel, three-light wood door provides access to the dwelling. Paired, two-over-two, single-hung, vinyl windows are located north of the door. A concrete slab porch is located on the north elevation. A single-light, picture window flanked by two-over-two light, single-hung wood-sash units is centered on the north elevation. Paired, two-over-two light, single-hung, wood-sash windows are located on the west end of the north elevation. A three-panel, three-light wood door is found on the east end of the elevation. The south elevation is four bays; windows are of various sizes and of paired or single configurations. All windows on the south elevation are of the same type as those on the north. Access to west elevation was not possible because it was covered in overgrown vegetation.

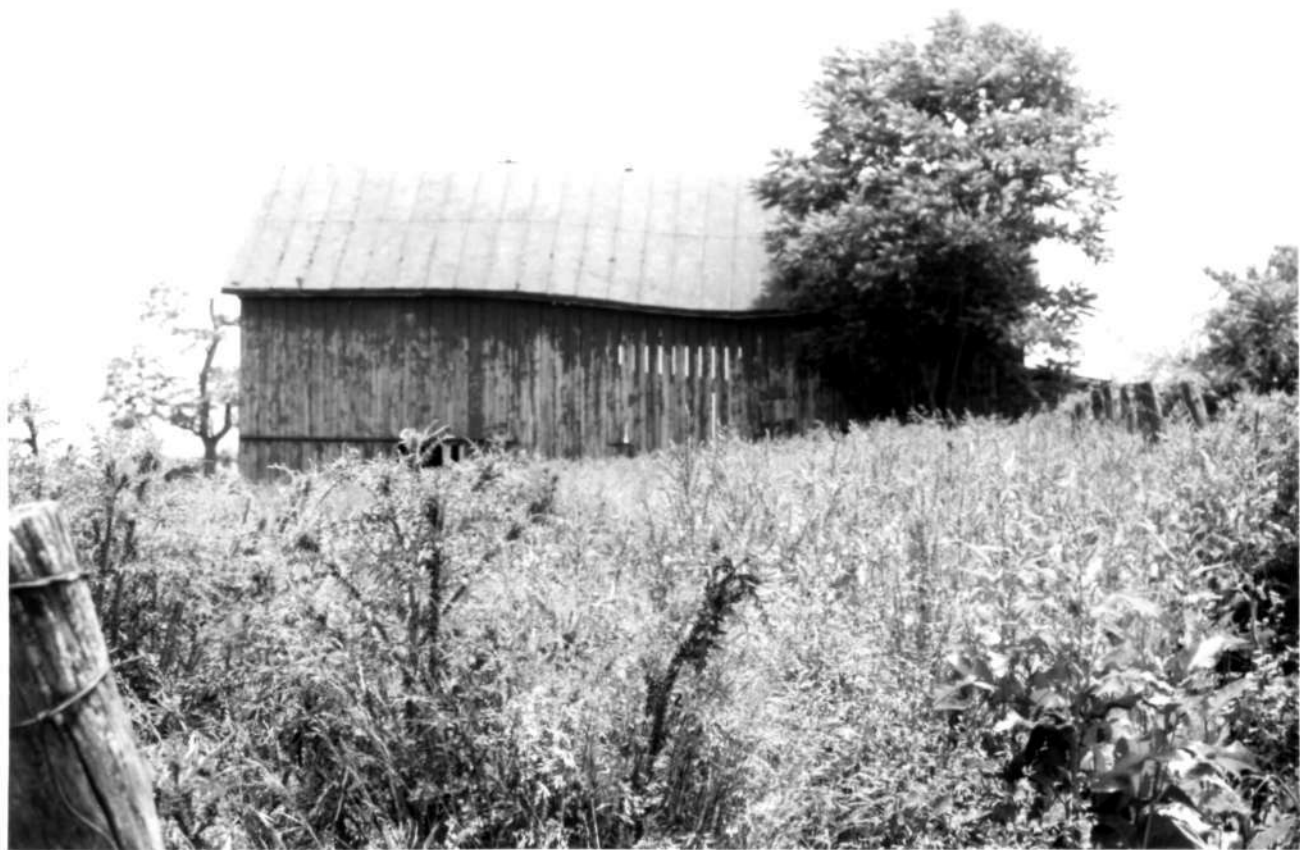
12 of 18

HORSE BARN, VIEW SE

The ca. 1900 horse barn is located west of the dwelling in an overgrown field. The barn occupies a rectangular plan and terminates in a gable roof sheathed in standing seam metal. The building is clad in wide, vertical wood plank siding. Two doors are located on the building. A two-story, sliding track, wood beaded board door is located on the south elevation. A second door is located on the north elevation and consists of a single-story, sliding track wood door. An addition was constructed on the west elevation. Access to the west elevation was not possible due to overgrown vegetation.

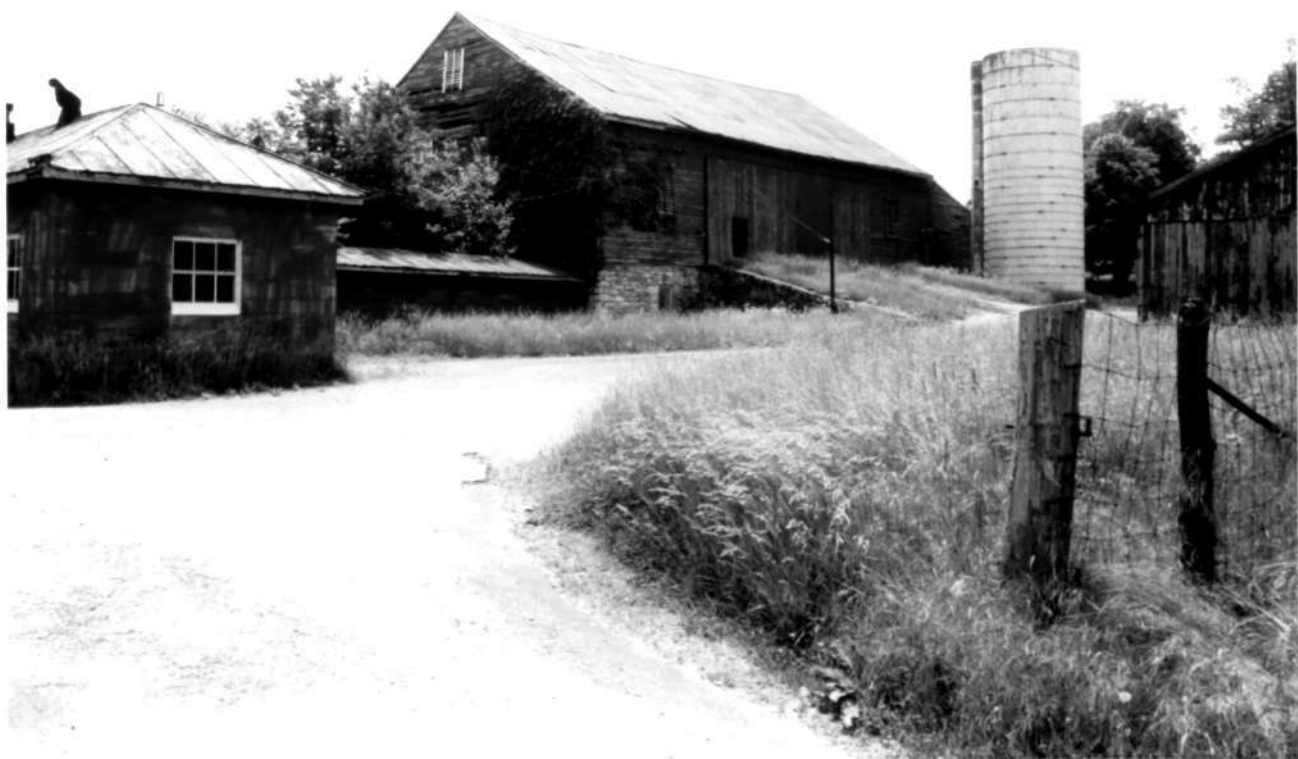
13 of 18

SILLO, BARK BARN, MILLING PARLOR, VIEW S

A ca. 1940 silo constructed of poured concrete is located at the west end of the north elevation of the bank barn. The silo occupies a round plan. The roof is no longer extant.

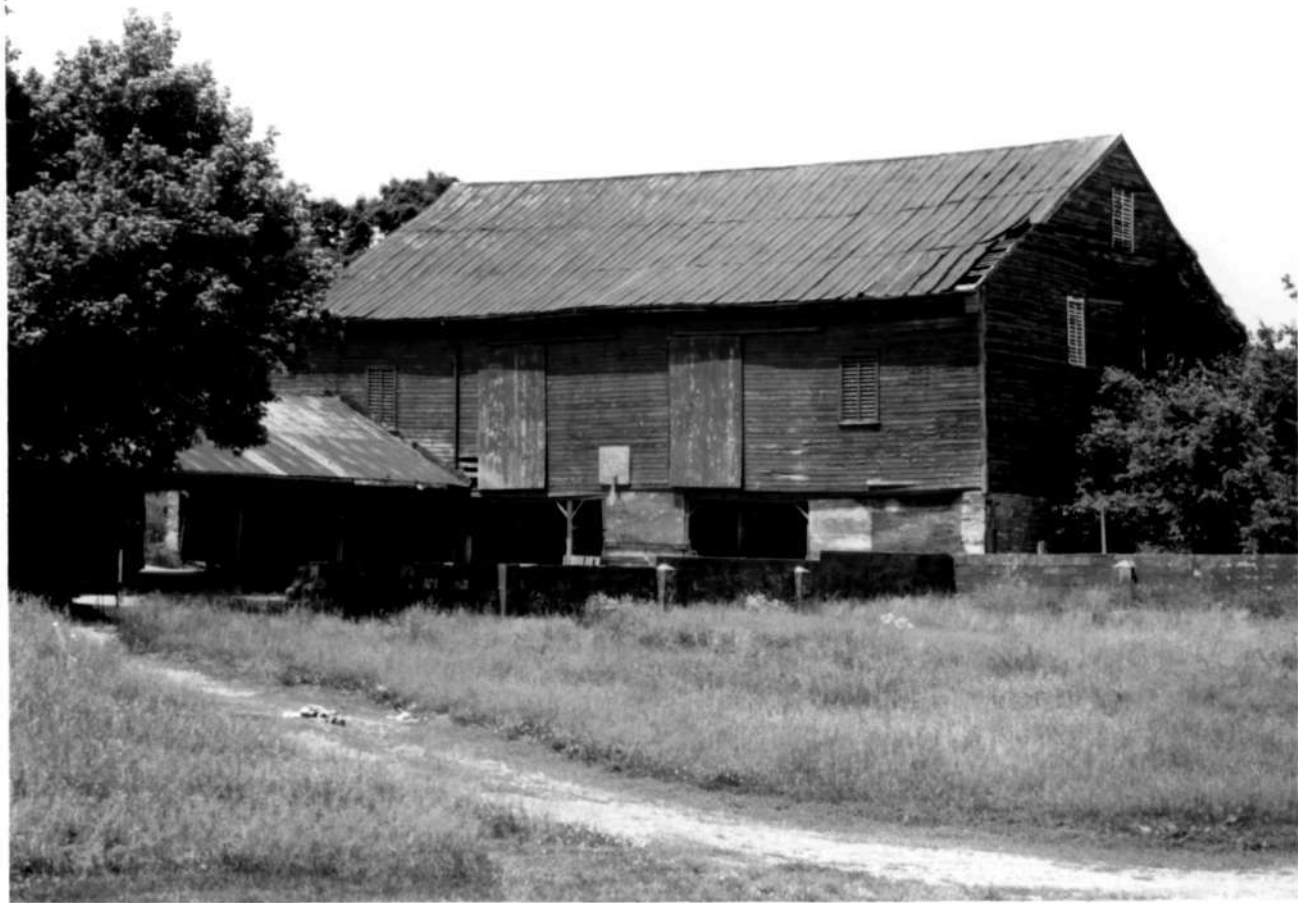
14 OF 15

BANK BARN AND LOADING STED, VIEW WEST

The ca. 1900 bank barn is located northwest of the dwelling. A three-foot tall concrete block wall creates an enclosed yard. The single-story building with loft occupies a rectangular plan and terminates in a gable roof sheathed in standing seam metal. The building rests on a stone foundation with a poured concrete floor. According to an inscription in the concrete, the slab was poured on 24 June 1954. The building consists of hewn log construction at the lower level; several H-bents have been removed from the structural system on the loft level. The exterior of the barn is clad in wood, German lap siding. The barn has seven bays on the forecourt. Louvered windows are located in the loft level of the east elevation and in the gables of both the east and west elevations. Louvered windows also are found at the loft level on the south elevation and are located adjacent to the sliding track doors. Two, sliding track, beaded board, wood doors are located at the loft level. A sliding track, beaded board wood door centered on the elevation also is located on the bank side (north) elevation. Louvered vents are located on either

A ca. 1960 loafing shed is located on the south elevation of and perpendicular to the west end of the bank barn. The building faces northeast. The single-story building occupies a rectangular plan. The building rests on a concrete slab and terminates in a gable roof clad in standing seam metal. Exterior cladding materials consists of concrete block. Vertical, wood plank siding is found in the south gable end and in the southern most bay of the northeast elevation. The building is divided into six bays that are defined by square, wood posts that rest on concrete piers. Six windows are located on the southwest elevation and consist of two-light, metal sash units. A single, shiplap wood door is centered in the southern bay of the northeast elevation.

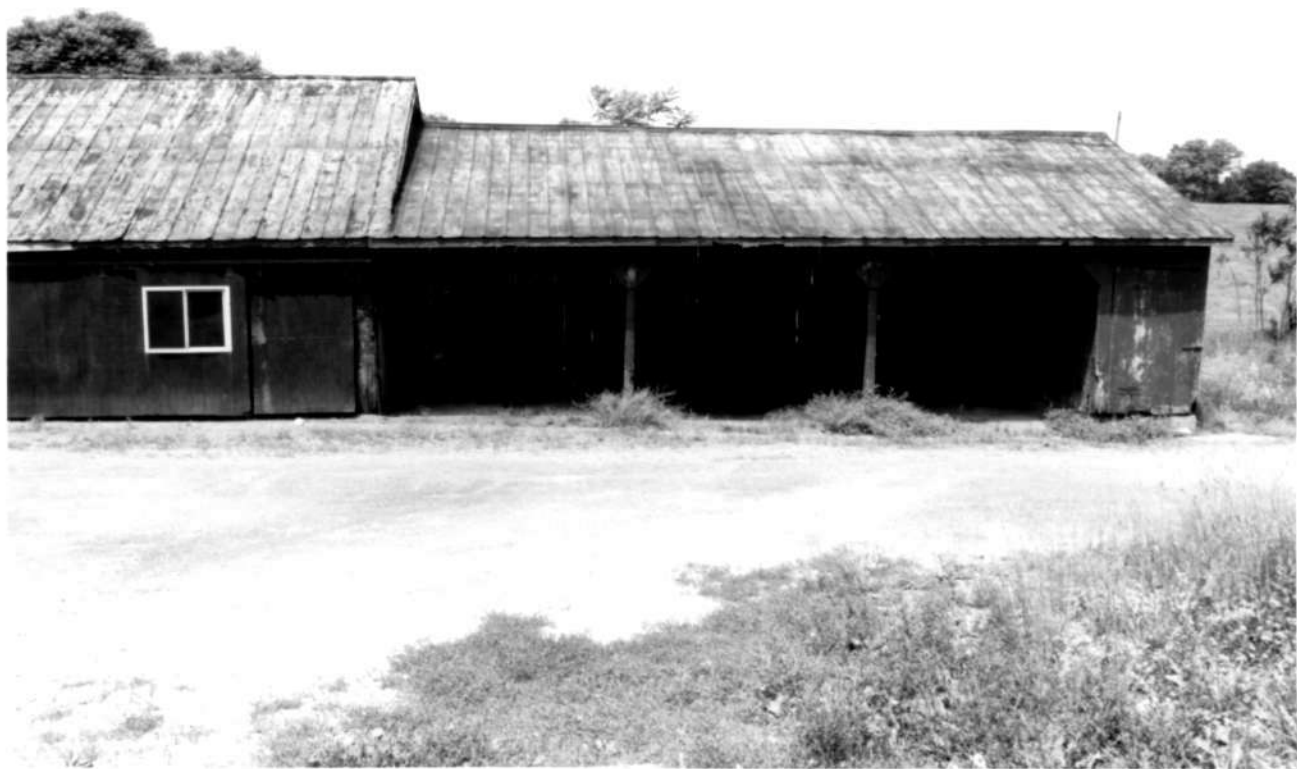
15 & 16

IMPLEMENT STAGE, VIEW NW

The ca. 1920 implement shed is located northwest of the dwelling and north of the bank barn. The building faces south. The one-story building occupies a rectangular plan and terminates in a gable roof. The wood-frame building rests on a dirt floor. Roofing materials consist of standing seam metal. The building is clad in vertical wood planks. The building is divided into three bays, which are defined by square, wood columns. A plank wood door with metal hinges is located at the east end of the building. A single-story addition was constructed on the west end of the building. A sliding-track door constructed of T1-11 wood siding extends the length of the building. A two-light, horizontal sliding, aluminum-sash window is located in the door.

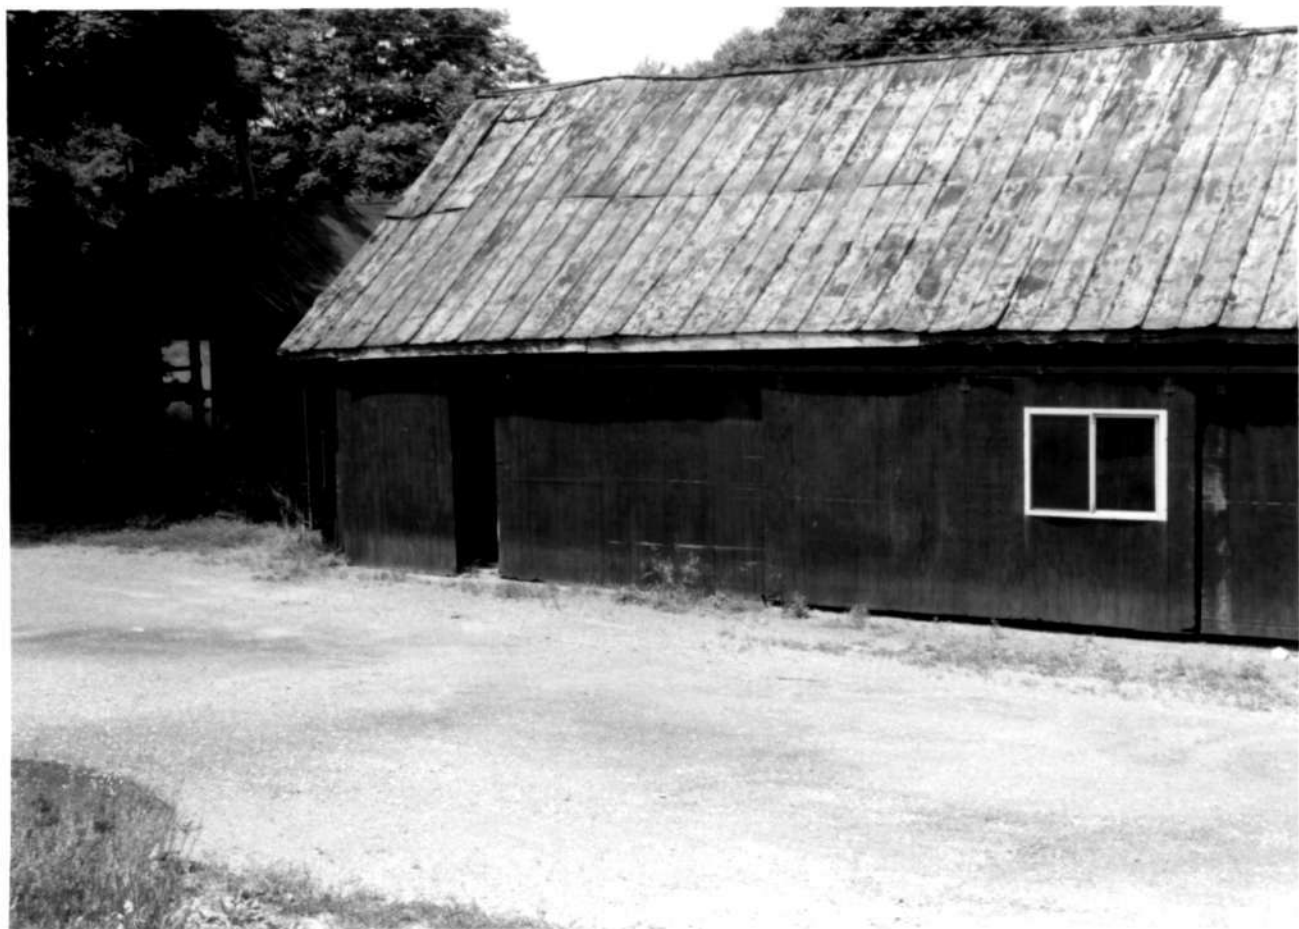
10 of 14

IMPLEMENT SHED, VIEW NW
